Cadence LGA ATC

Test Summary

TR – 205047ATC

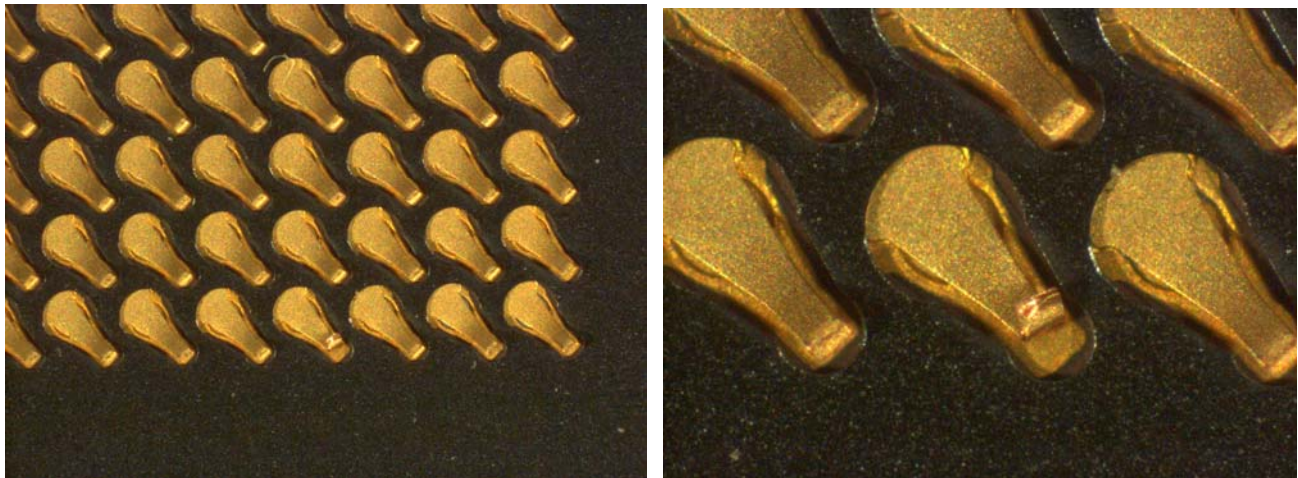
Time-zero continuity resistance measurements were taken on each test board. There was one (1) T0 open on LGA position 4 on test board 28D122706. After dismantling the socket assembly it was discovered that LGA pin AN04 was bent and made an indentation on the test board off of the contact land.

Here are photos taken on the back side of the LGA connector showing the bent AN04 pin:

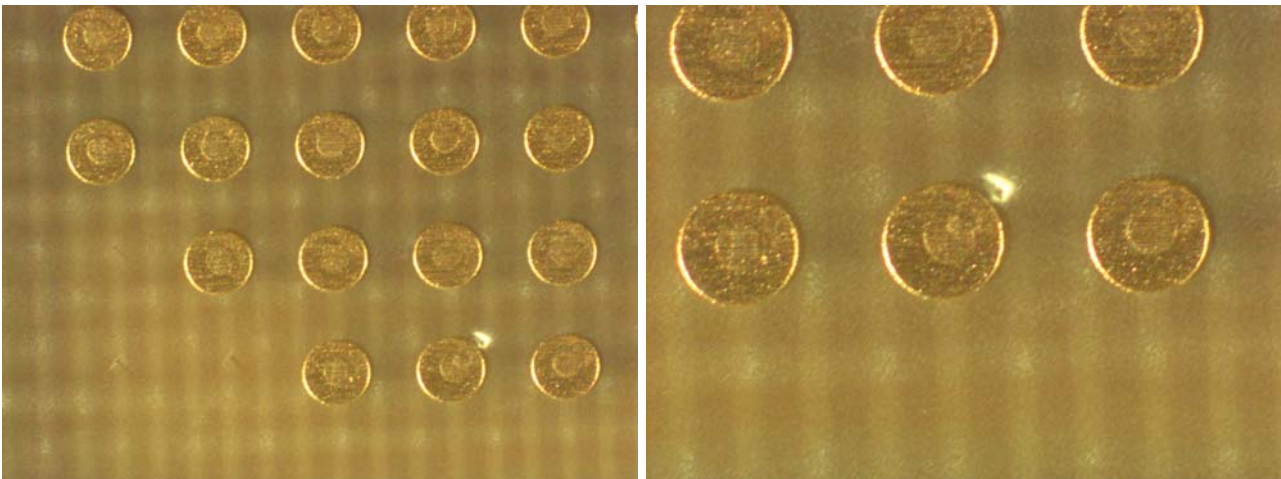
Here are photos taken of the mating pad position on the test board:

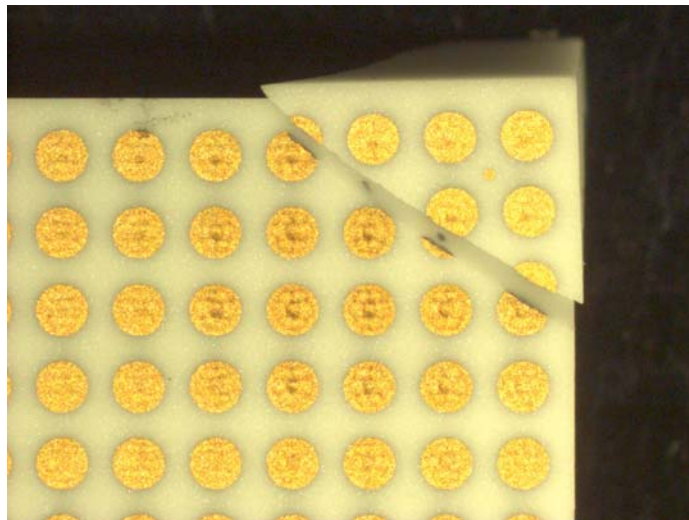
Two fails were noted: Position 4 on 28D122699 and Position 1 on 28D122706.

After dismantling the Position 4 socket assembly on 28D122699 it was discovered that the corner of the ceramic test module was cracked.

Following ship shock an additional spacer was added to all of the “Brown” LGA sockets. Two additional actuations were exercised on these positions with continuity measurements taken following each actuation.

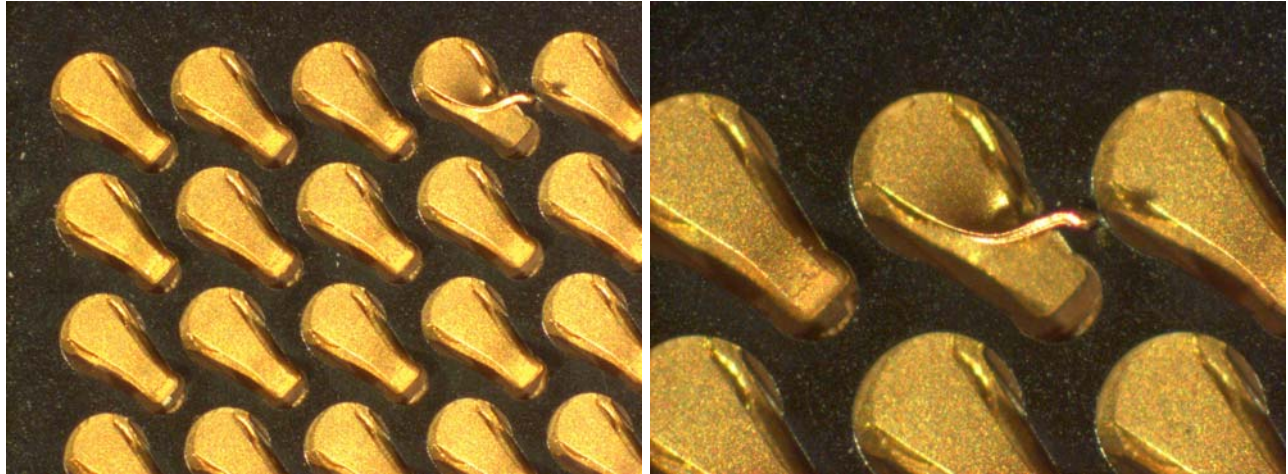
After dismantling the Position 1 socket assembly on 28D122706 it was discovered that LGA pin A30 was bent and made an indentation on the test board adjacent to the contact land.

Here are photos taken on the back side of the LGA connector showing the bent A30 pin:

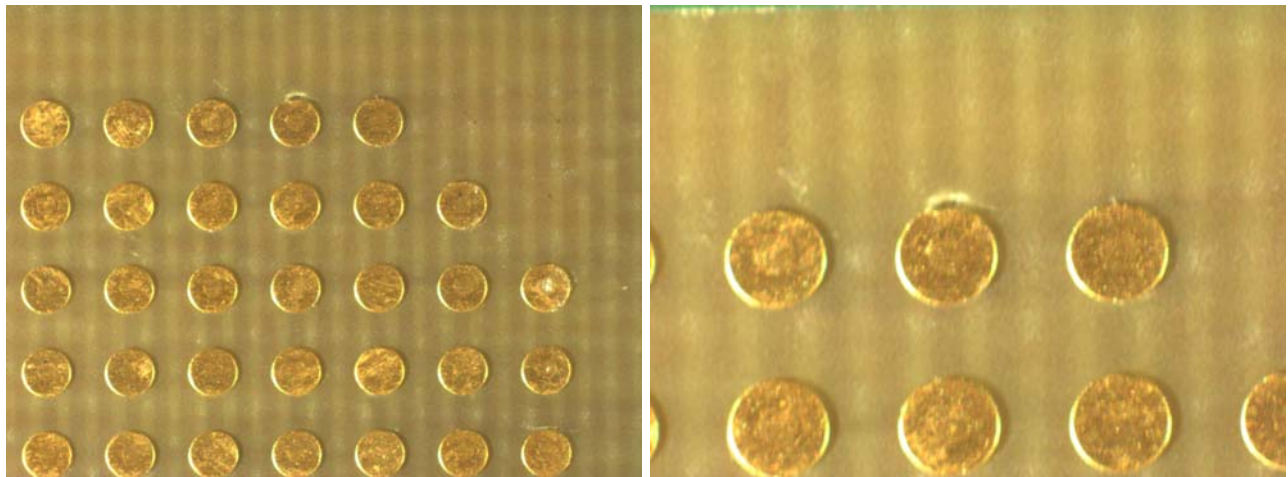
Here are photos taken of the mating pad position on the test board:
